STATE OF MAINE DEPARTMENT OF TRANSPORTATION

EXPERIMENTAL CONSTRUCTION (99-8)

Experimental Use of Geogrids As An Alternative To Gravel Placement

Interim Report - First Year

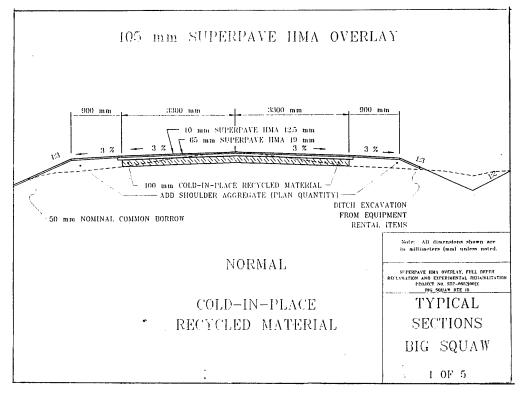
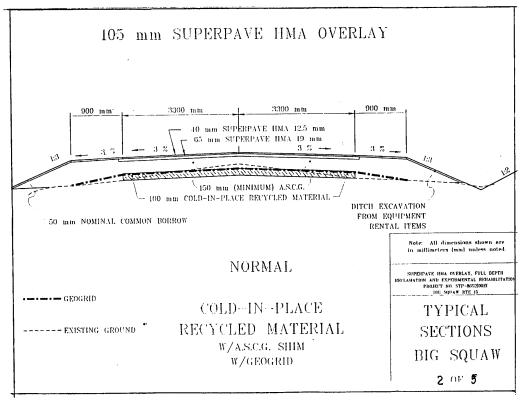
Typical Cross Section Details

Final pavement depths for the project consisted of 65 millimeters of Superpave 19 mm binder course, and Superpave 12.5 mm surface course at depths ranging from 30 to 100 millimeters (see attached Typical).

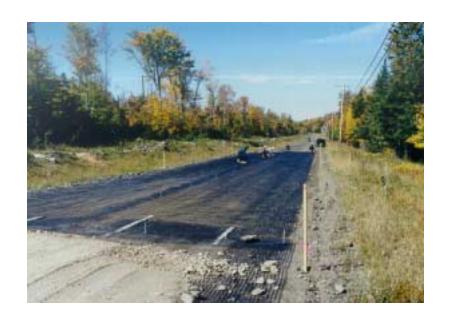
Geogrid Placement 50-meter length - full roadway width

In the four-geogrid sections (2, 5, 7 and 9), existing pavement material and 25 mm of gravel base material were ground in-place and leveled to grade using a grader to eliminate excessive crown. Two rolls of geogrid product, each measuring 4 meters in width and approximately 50 meters in length were then placed on top of the grindings full roadway width. Construction of each geogrid section was completed using this 50-meter interval to minimize traffic interruptions.

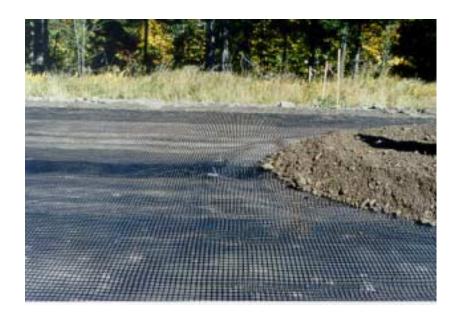
Variable Depth Gravel Placement

Both lanes of traffic were stopped during this process, until a single lane width layer of gravel of varying depth (300 mm minimum) could be placed over the longitudinal seam at the center of the roadway. Once single lane traffic flow was reestablished, the left and right side of the geogrid was covered to a total width of 7.3 meters. Some "pushing" or "waving" of the geogrid product was noted during gravel application (see attached photos). This movement was not considered critical but it did create concern with respect to ease of application.

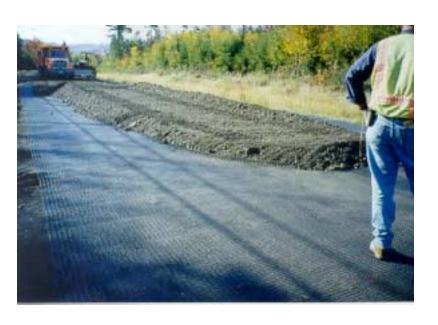
Pushing or Waving of Geogrid Material

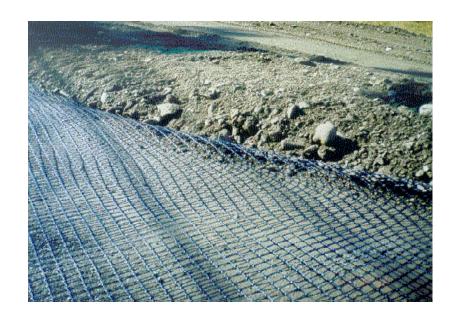
Close-up of "Waving" Grid

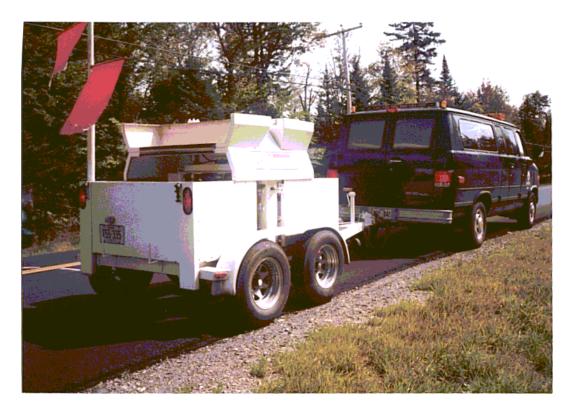
Falling Weight Deflectometer

On September 22, 2000, FWD testing was completed in each of the 11 sections. Four drops, each generating approximately 9000 pounds of force, were used at each test location (see attached photo). Deflection measurements were recorded and this data was then analyzed using <u>DARWin 3.01</u> software. Overall Subgrade Modulus, Pavement Modulus and Effective Existing Structural Numbers were then developed for each section. These values were computed using a minimum of 10 test points per section.

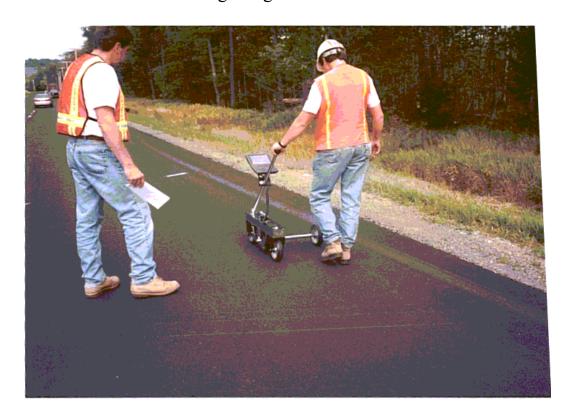
Rolling Dipstick

As detailed in the Construction report for this project, the Department's "Rolling Dipstick was utilized in an effort to monitor vertical movement of eight cross culverts along the project (see attached photo). Data was collected in March 2000 and again in September 2000 as part of the annual evaluation process. Comparisons of IRI readings were made for fall 1999 and fall 2000, and spring and fall 2000. Overall, IRI readings displayed minimal change from 1999 to 2000 with the exception of culvert #4 located in one of the geogrid sections at station 3+432. The end of the culvert at this location appears to have lifted near the edge of the northbound travel way. Table IX (attached) summarizes this comparison.

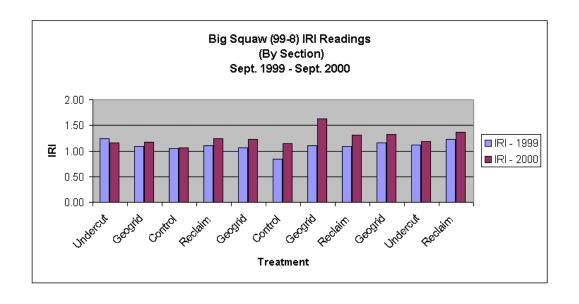
TABLE V

Big Squaw - Route #15 (99-8) IRI Readings (By Section) Sept.1999 - Sept. 2000

The ARAN collected a complete series of project data late in the fall of 2000. Roughness and rutting data was compared to data collected in the fall of 1999 in an effort to track deterioration. With the exception of Section 7 that fell into the "comfortable ride at 55 mph/88 kph" category, roughness readings remained in the category "comfortable ride at 65 mph/105 kph". Roughness is presented as International Roughness Index (IRI) in metric units. Figure I (attached) presents the range of IRI values and a verbal description of each. Roughness data is summarized in the attached Table V.

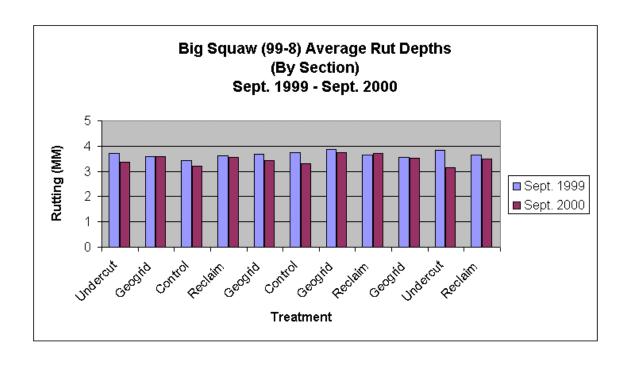
TABLE VI

Big Squaw Route #15 (99-8) Average Rut Depths (By Section) 1999-2000

Fall 2000 rutting data actually indicated a decrease in rut depths when compared to the fall of 1999 data in all sections except Section 2 and Section 8. It is important to note, the ARAN measures rut depths in millimeters and even the slightest deviation in

positioning of the vehicle during data collection can skew the results. It is anticipated that this data will become more valuable in future evaluations when more prominent rutting develops. Table VI (attached) summarizes the 1999 and 2000 rut data.

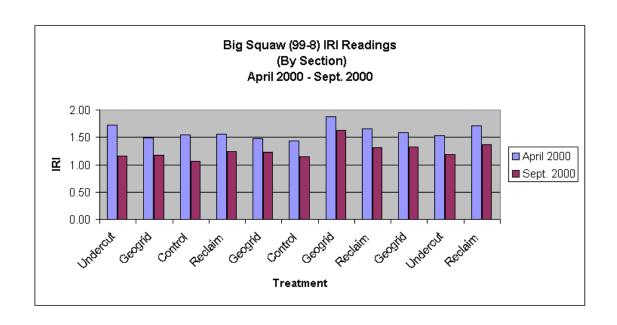
TABLE VII

Big Squaw - Route #15 (99-8) IRI Readings (By Section) April 2000 - Sept. 2000

Analysis was also completed on spring 2000 data for both roughness and rutting. Roughness measurements from the spring of 2000 indicated a slightly less desirable reading than the readings collected in September 2000. Sections 2, 3, 4, 5, 6 and 10 remained in the "comfortable ride at 65 mph/105 kph" category. The remaining sections were categorized as "comfortable ride at 55 mph/88 kph". These results are summarized in Table VII (attached).

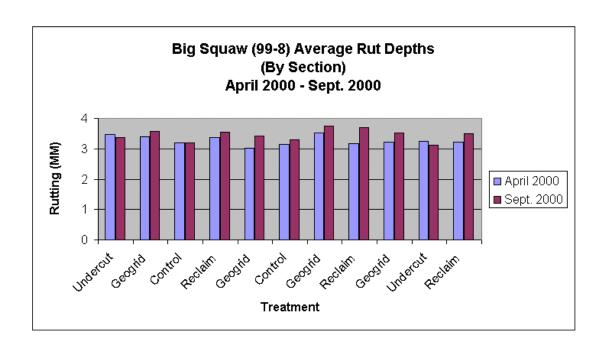
TABLE VIII

Big Squaw Route #15 (99-8) Average Rut Depths (By Section) April 2000 - Sept. 2000

Overall, the comparison of spring and fall rut data was inclusive. Spring rut depths were actually less in all sections with the exception of sections 2 and 10. This data is summarized in Table VIII (attached).

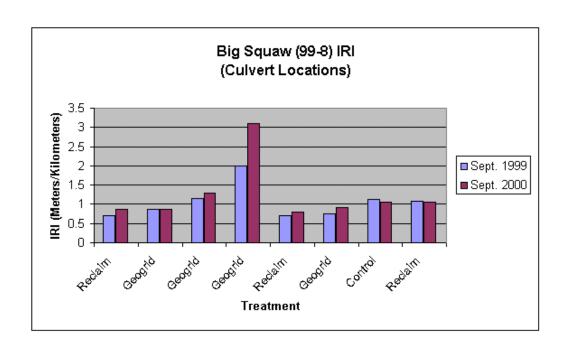
TABLE IX

Big Squaw - Route #15 (99-8) Rolling Dipstick (Sept. 1999 - Sept. 2000) International Roughness Index (IRI) (CULVERTS)

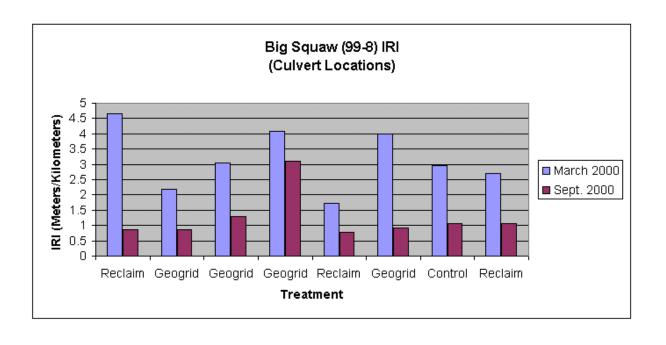
TABLE X

Big Squaw - Route #15 (99-8) Rolling Dipstick (March 2000 - Sept. 2000) International Roughness Index (IRI) (CULVERTS)

The spring-fall comparison indicated significant movement occurred at each culvert. Interestingly, Culvert #4, which displayed significant movement in the fall 1999-fall 2000 comparison, displayed the least amount of movement (32 percent) for this evaluation. This data is summarized in Table X.
